**“To Keep the Banks, Dams and Sluices in Repair”
 An Historical Context for Delaware River Dikes
 New Castle County, Delaware**

Prepared for the
 New Castle Conservation District
 and the
 Delaware Department of Natural Resources

by
 John Milner Associates, Inc.

December 2013

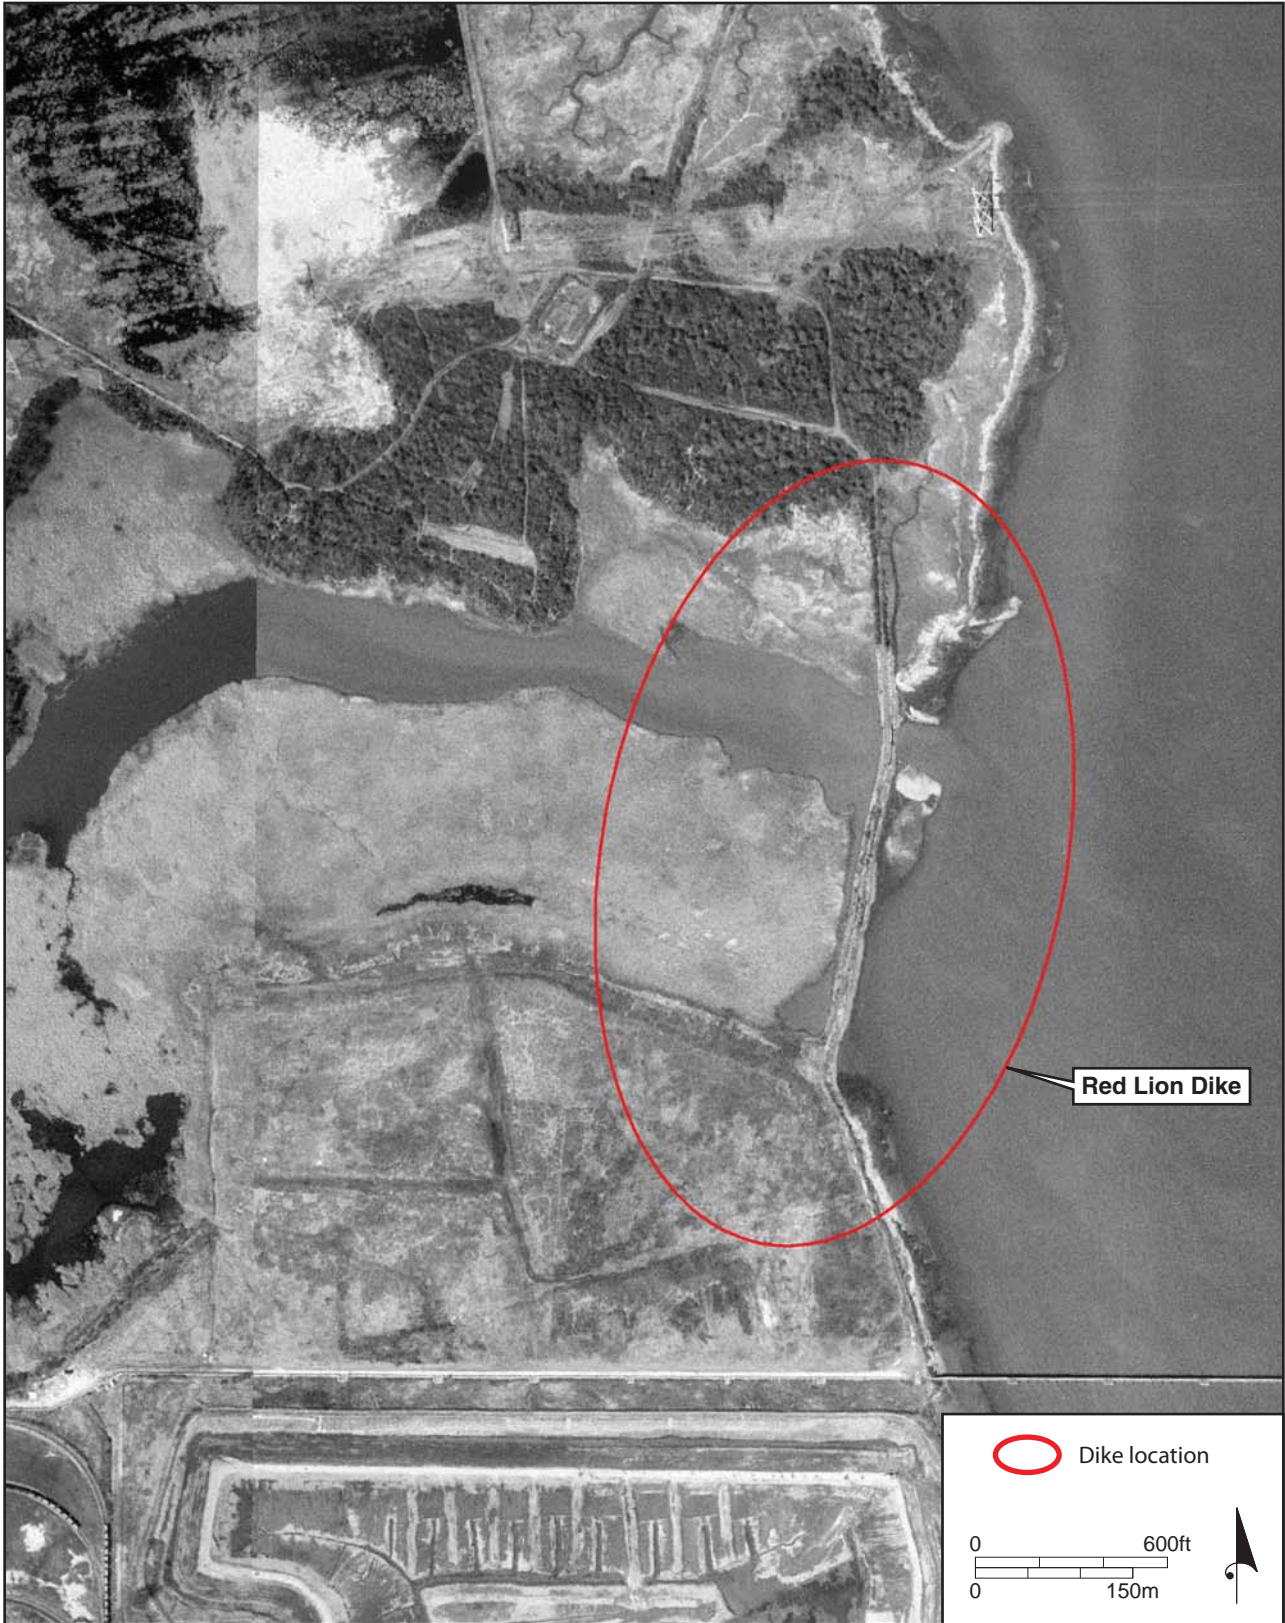
Map 21. Aerial photograph showing the Red Lion Dike (DelDOT 1997).

After 1968, a new sluice was installed at the location of the old sluice depicted in 1813 (Map 21). The location of the sluice installed after 1813 is evident today by the remnant of a concrete channel. The use of concrete suggests that the original sluice, assuming that it had been installed ca. 1814, had been replaced at some point in time. A short distance to the north of this location the dike retains a section lined with stone. It is not clear from aerial photographs if a larger portion of the dike had been stone-lined, but is not longer extant.
